**APPENDIX B**

**SITE VISIT PHOTOGRAPHS**

**PARCEL 1**

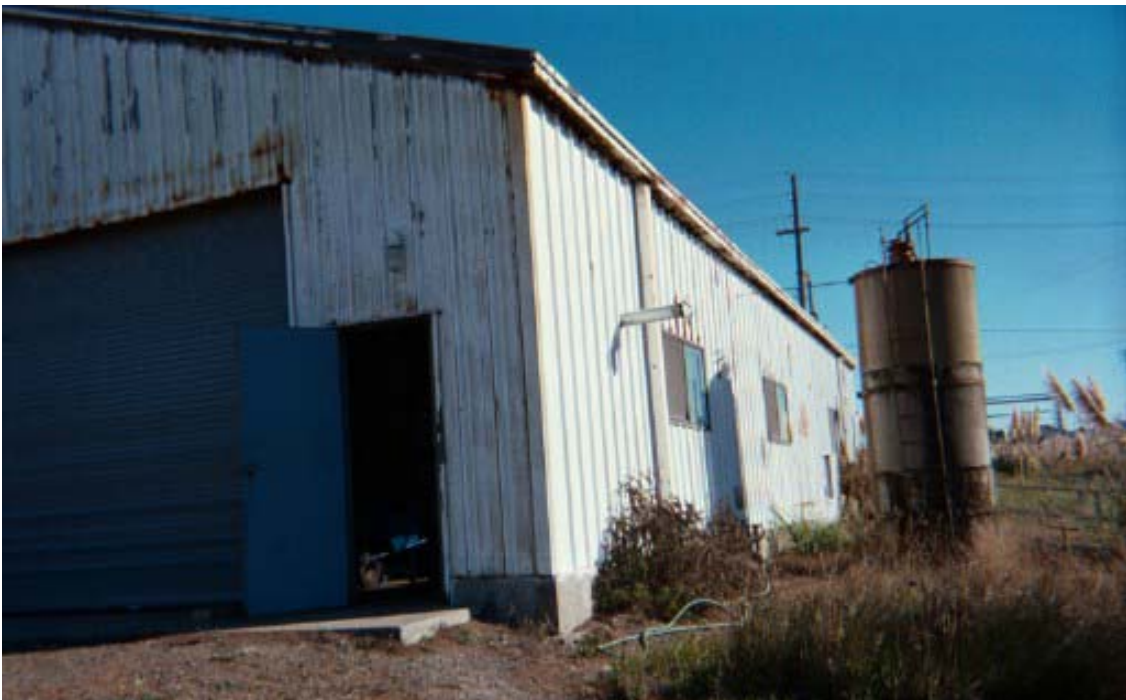
Photo 4. View of water treatment plant and cement AST.

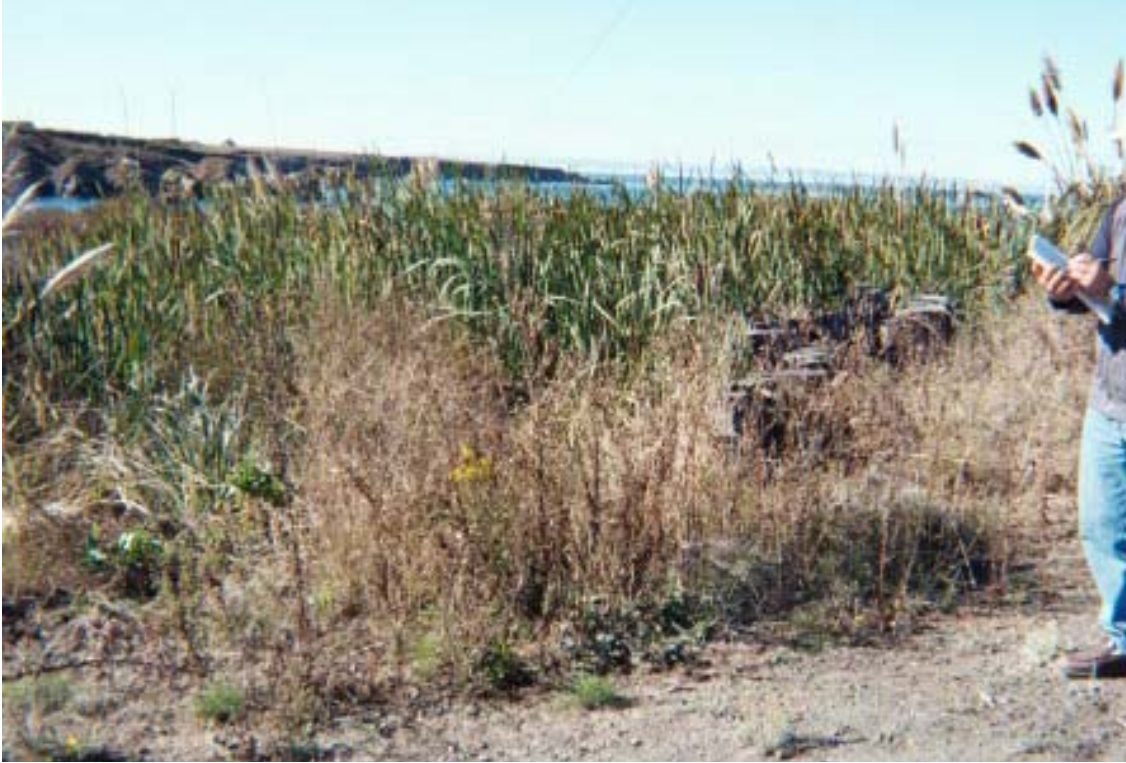
Photo 5. North settling pond with thick vegetation.

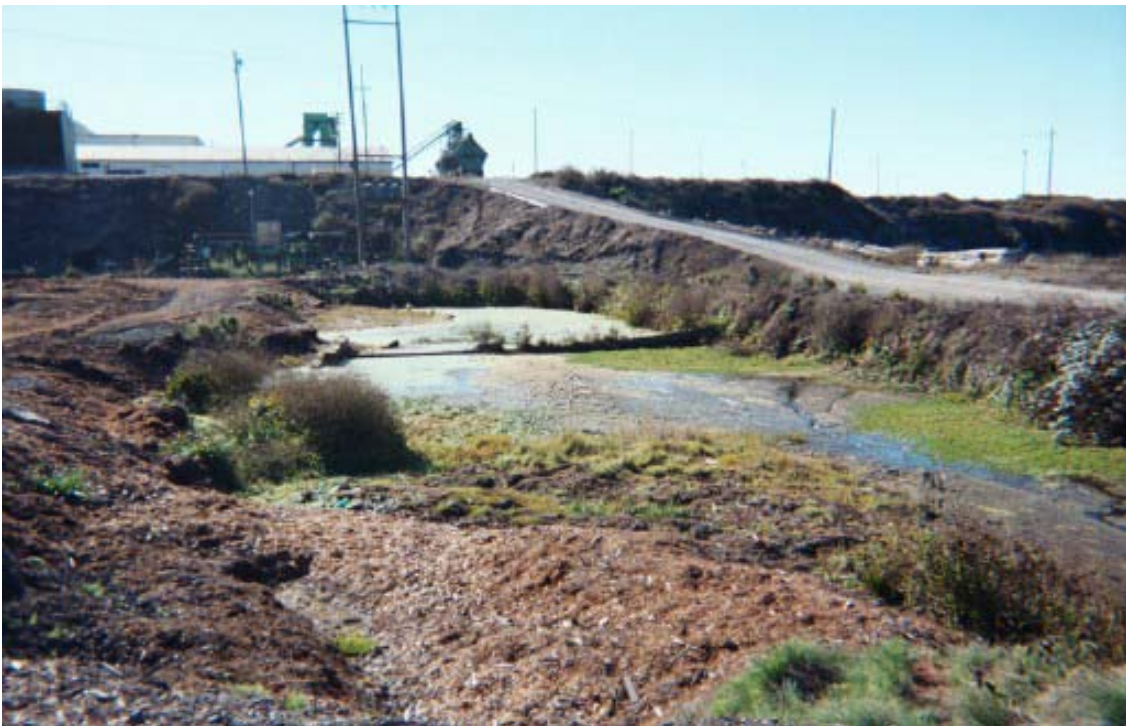
Photo 6. Collection Pond in the west area of Parcel 4.

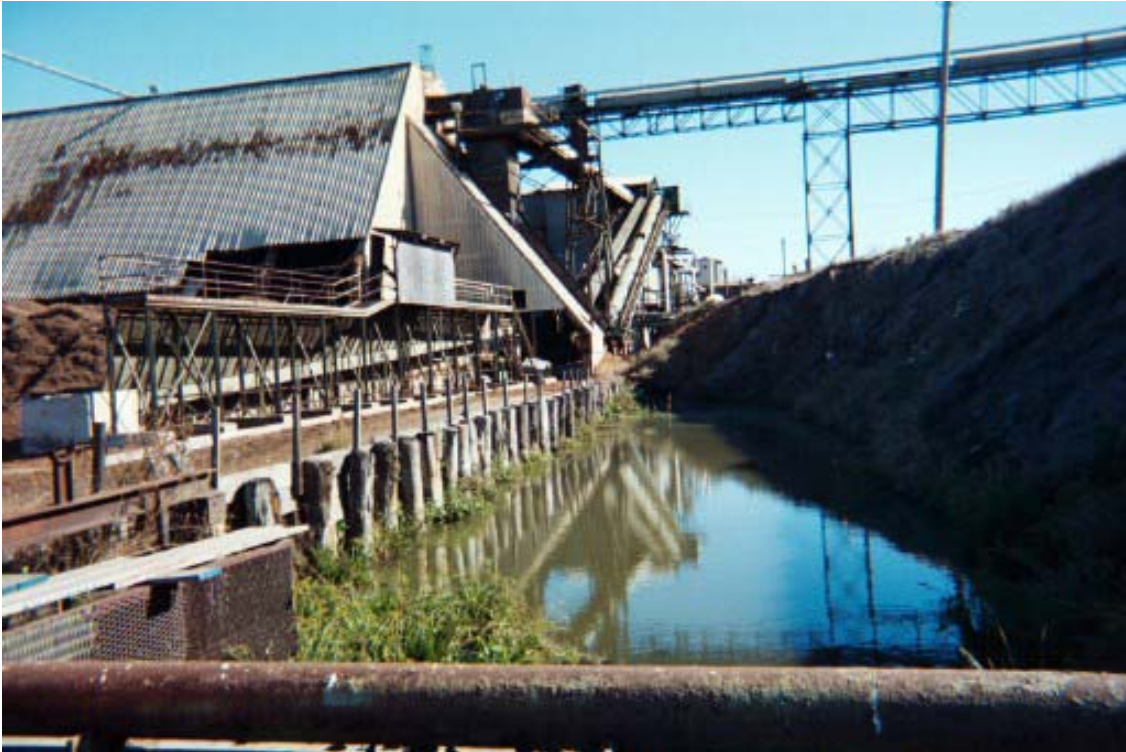
Photo 7. View of south settling pond. Note the fuel barn on the left side.

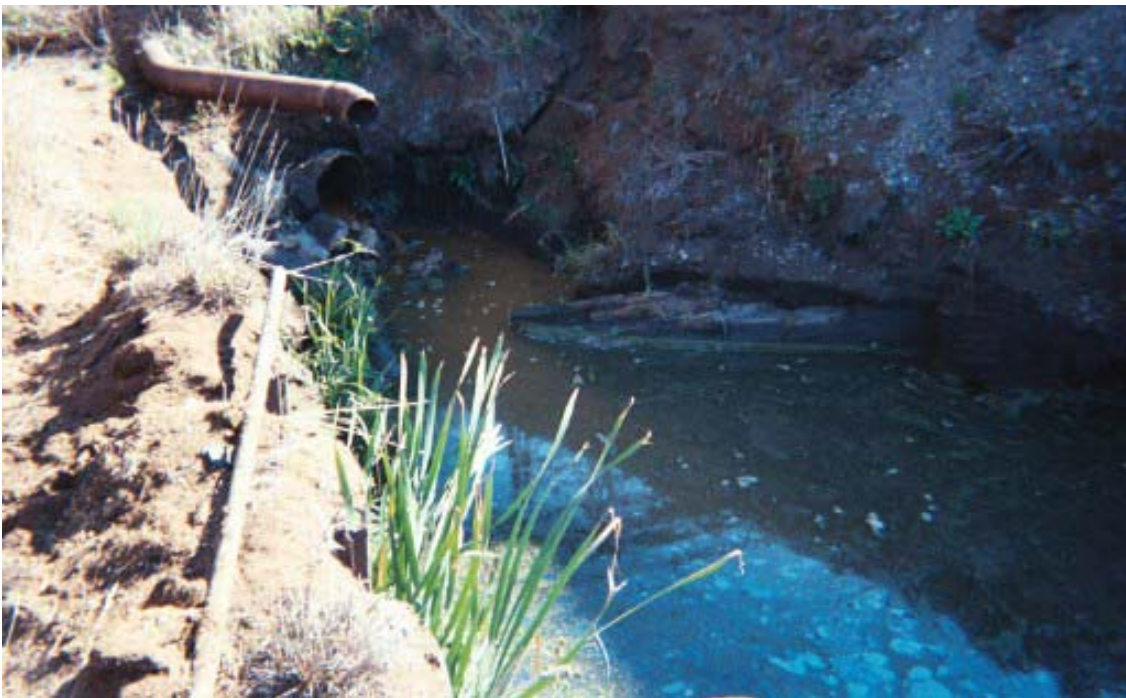
Photo 8. East end of south settling pond with visible sheen on the water.

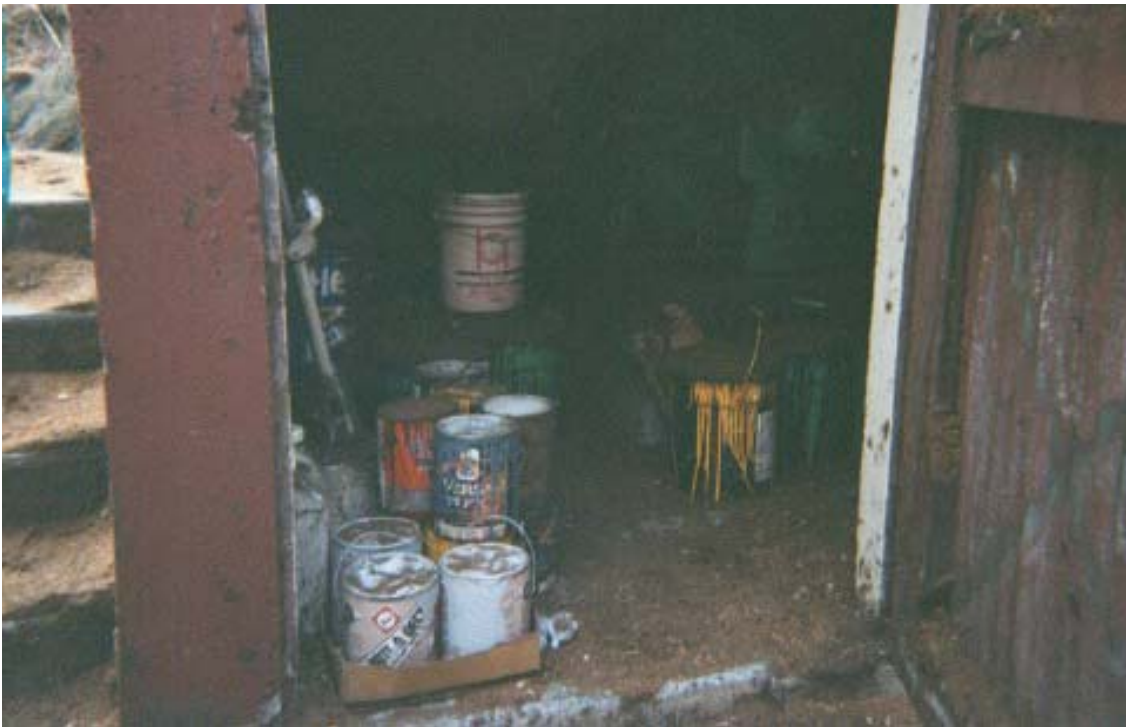
Photo 10. Paint storage shed on the south side of the power house. Paint and supplies have been removed.

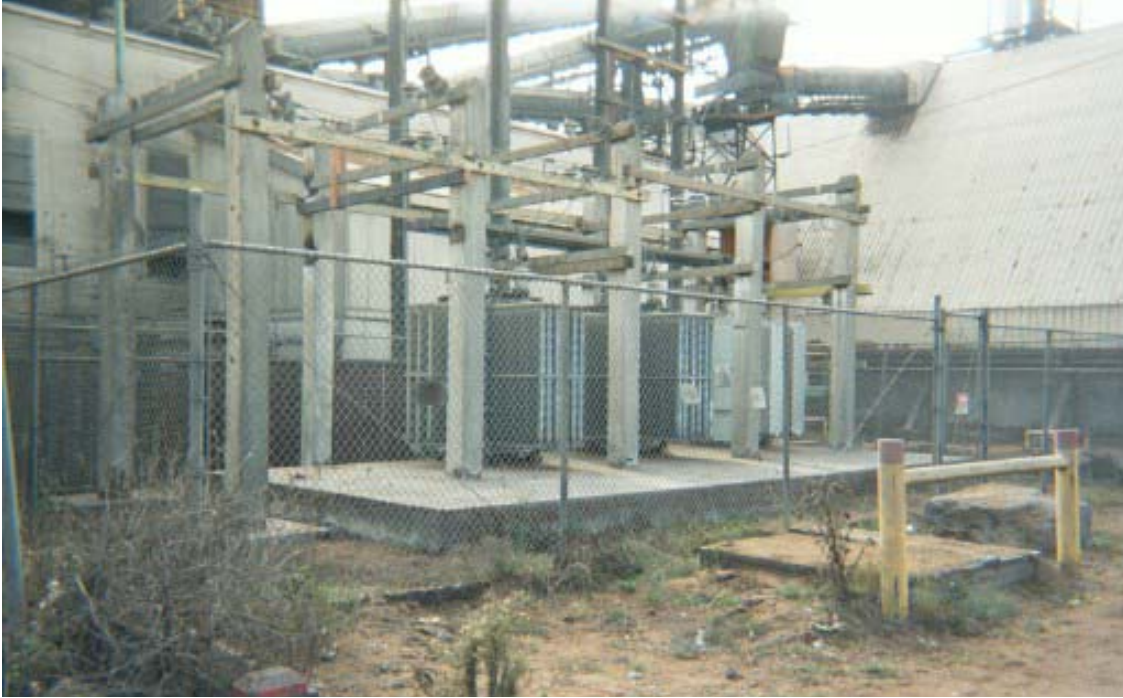
Photo 11. Transformer pad on the north side of the power house.

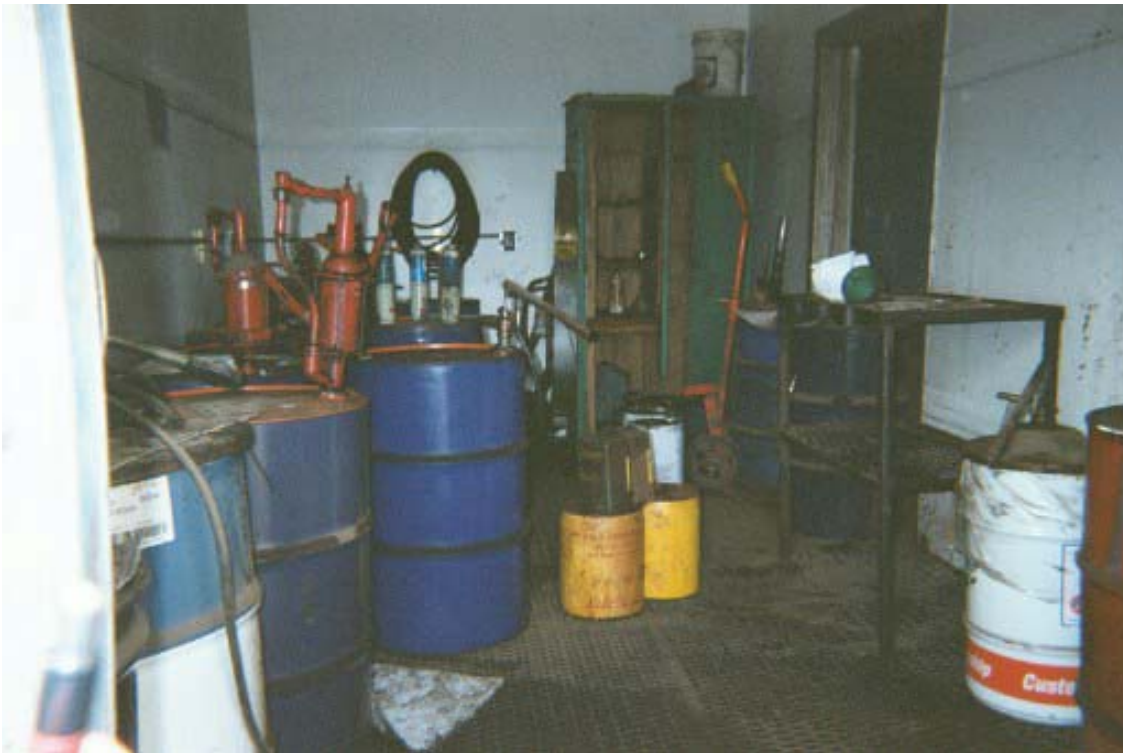
Photo 12. Inside oil storage shed. Oil and containers have been removed.

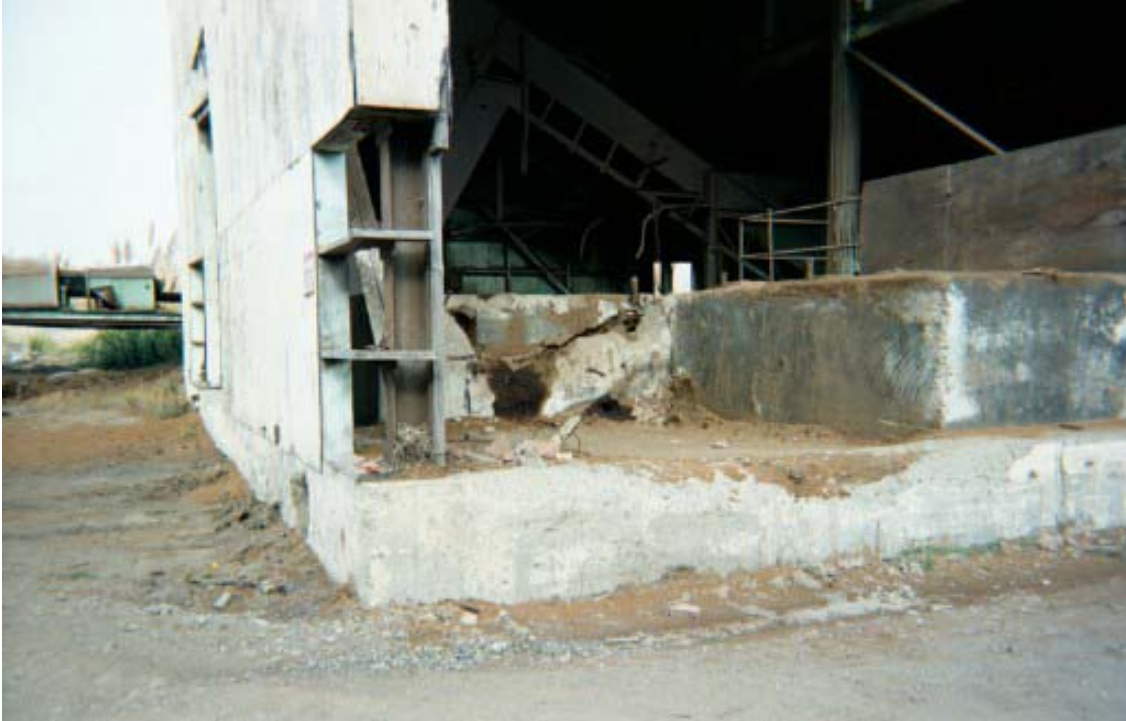
Photo 13. Location of former sugar cane press in southwest corner of press building.

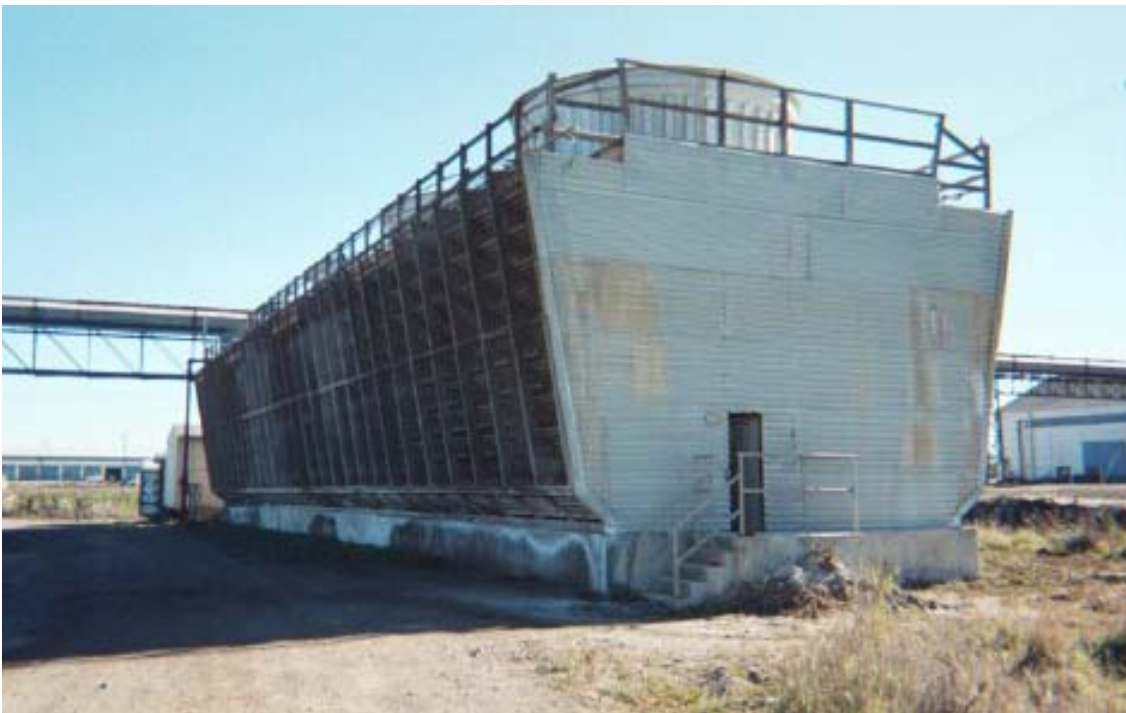
Photo 14. View of the cooling towers. Chemical tanks and shed are located on the other side of cooling towers building.

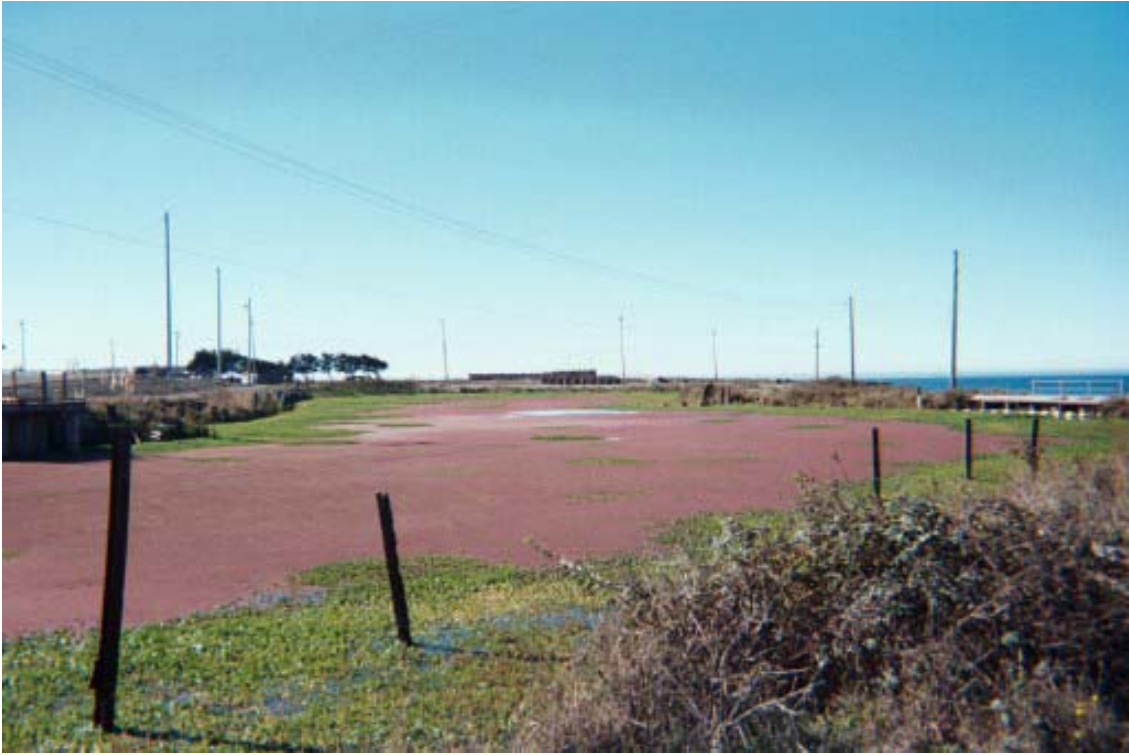
Photo 15. View of log pond on Parcel 4 looking southwest.

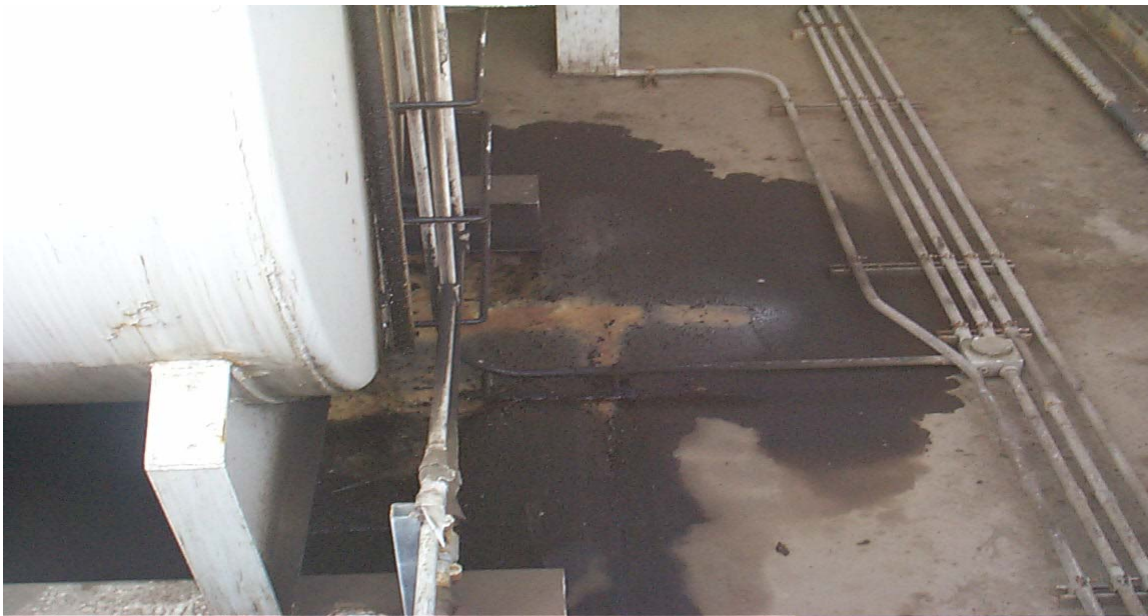
Photo 4. Staining within concrete berm inside Fuel Dispenser and Storage Building.

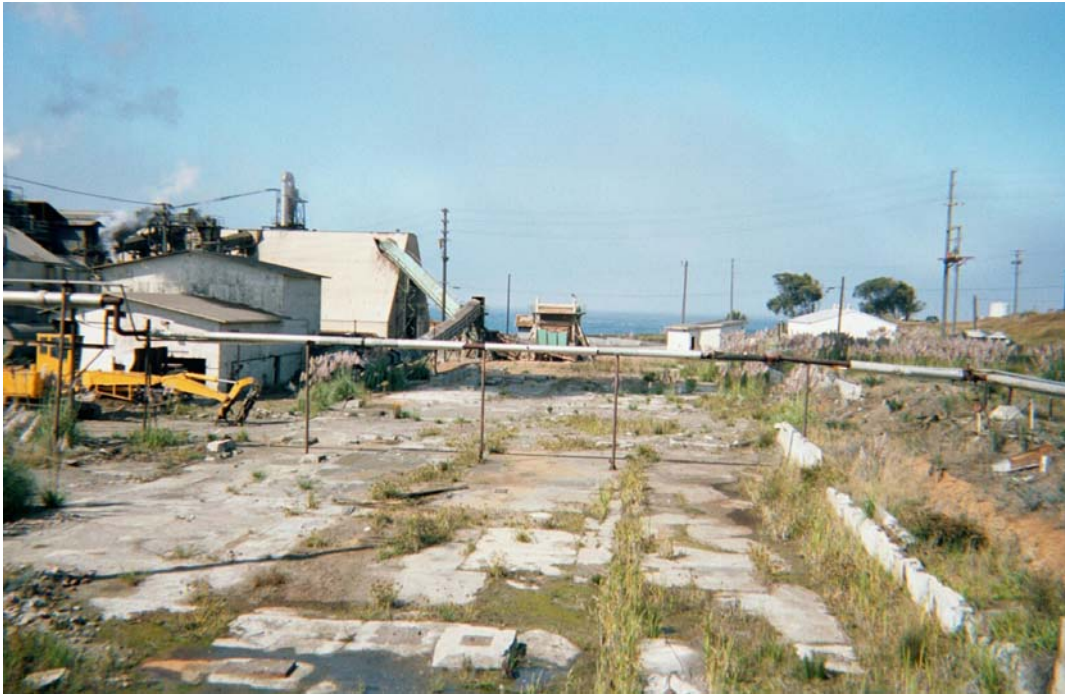
Photo 5. Location of former Sawmill #1.

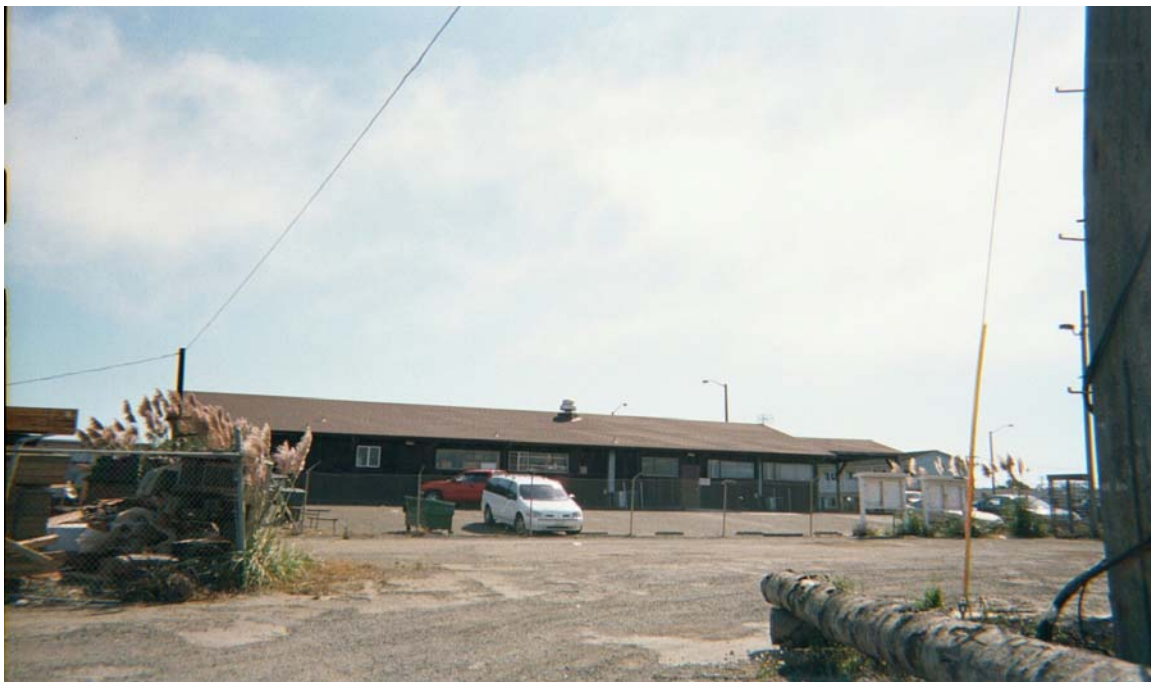
Photo 6. Mendocino County Hospital Office Buildings located along Highway 1.

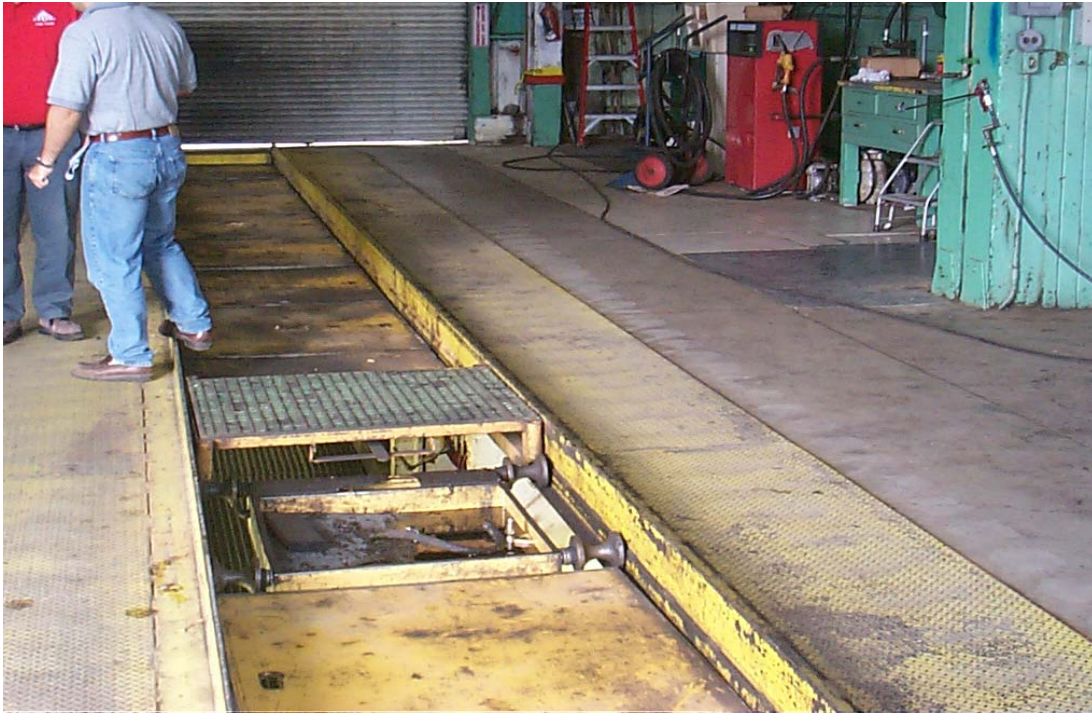
Photo 7. Oil Change Pit located within Mobile Equipment Shop.

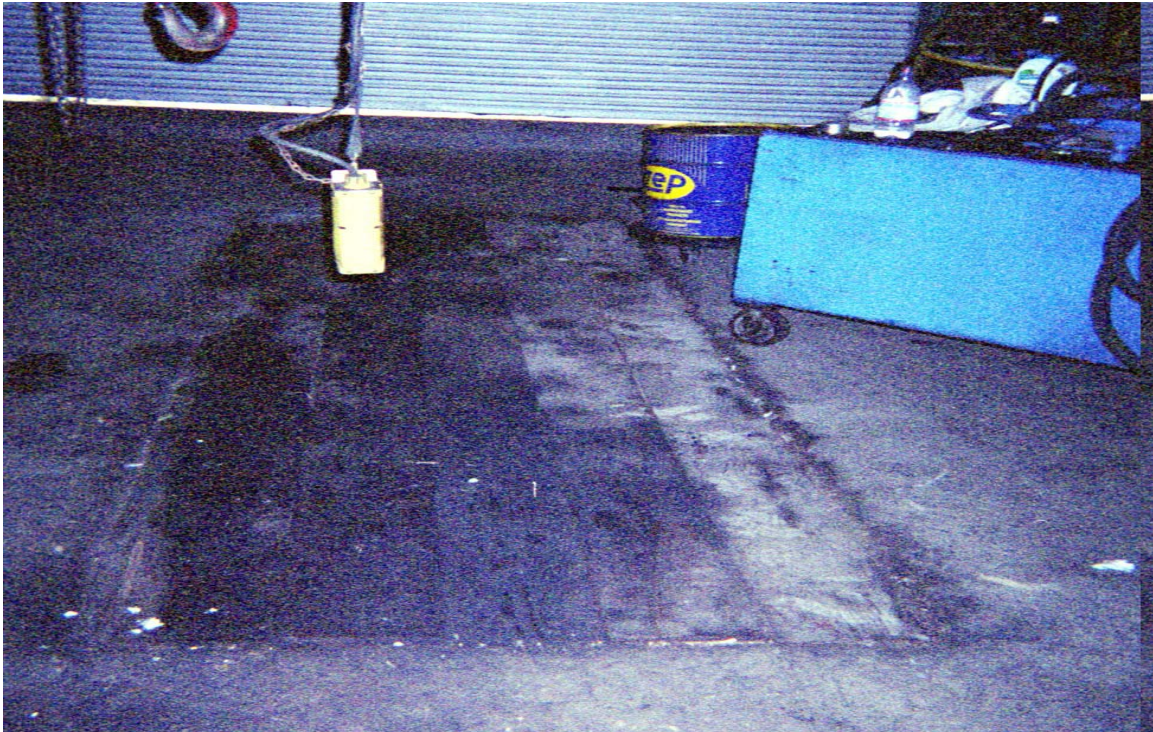
Photo 9. Covered Pit located inside Mobile Equipment Shop.

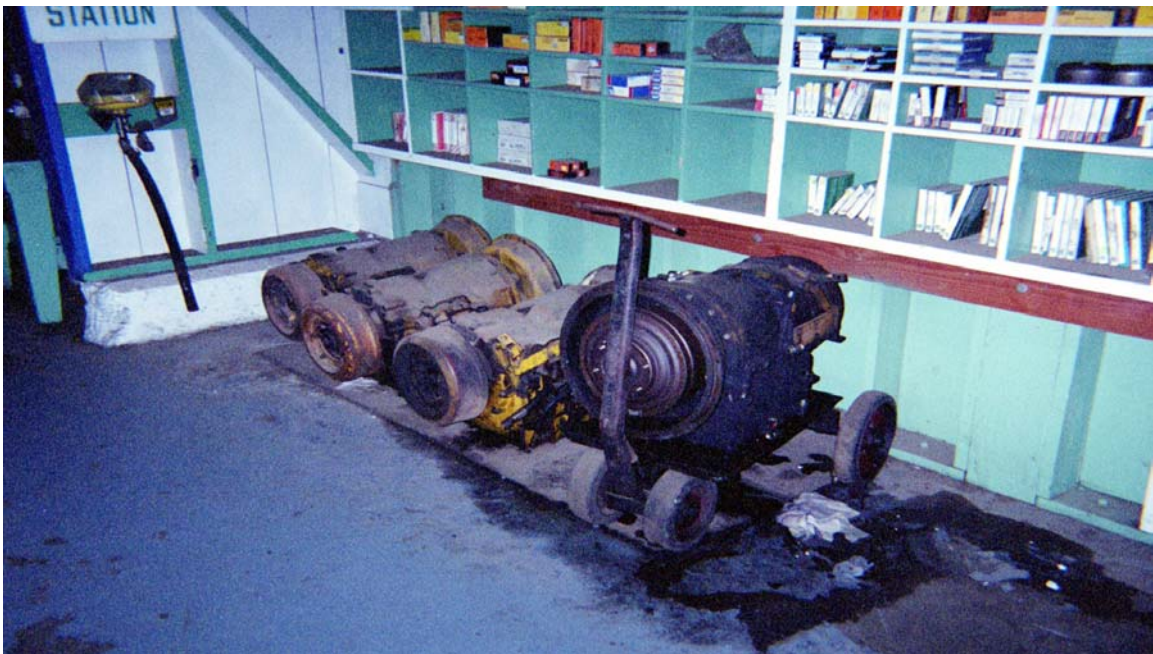
Photo 10. Engines stored in Mobile Equipment Shop (some surface staining). Engines have been removed.

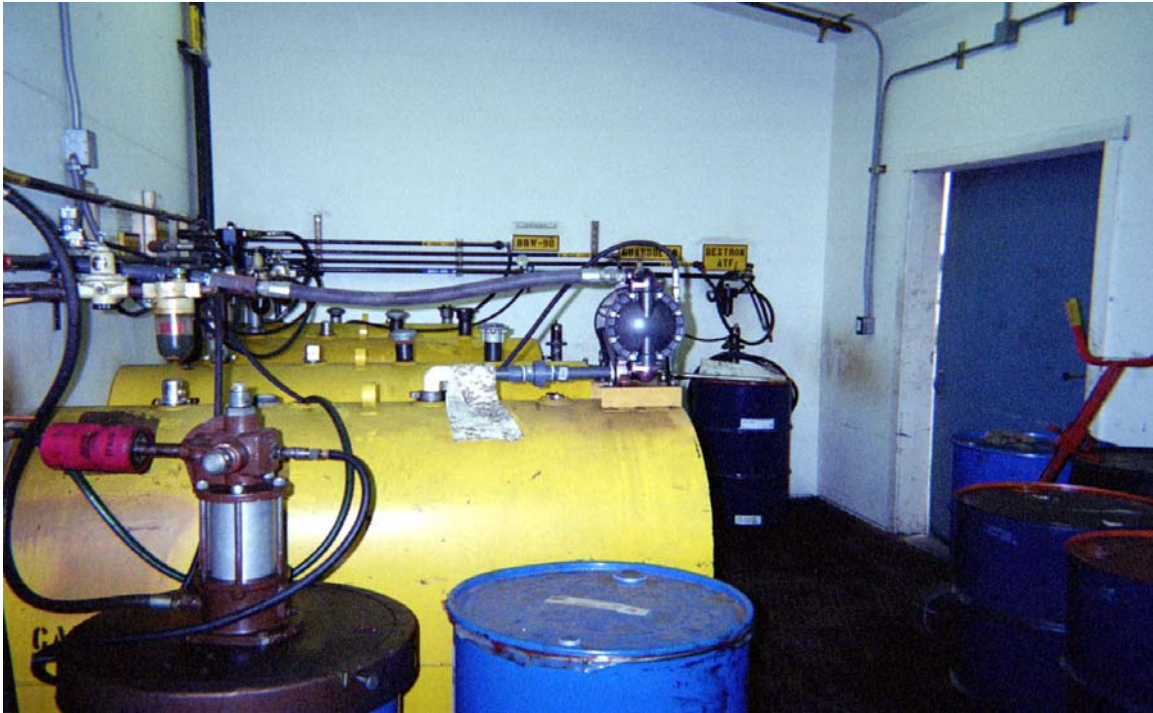
Photo 11. North Shed – Mobile Equipment Shop.

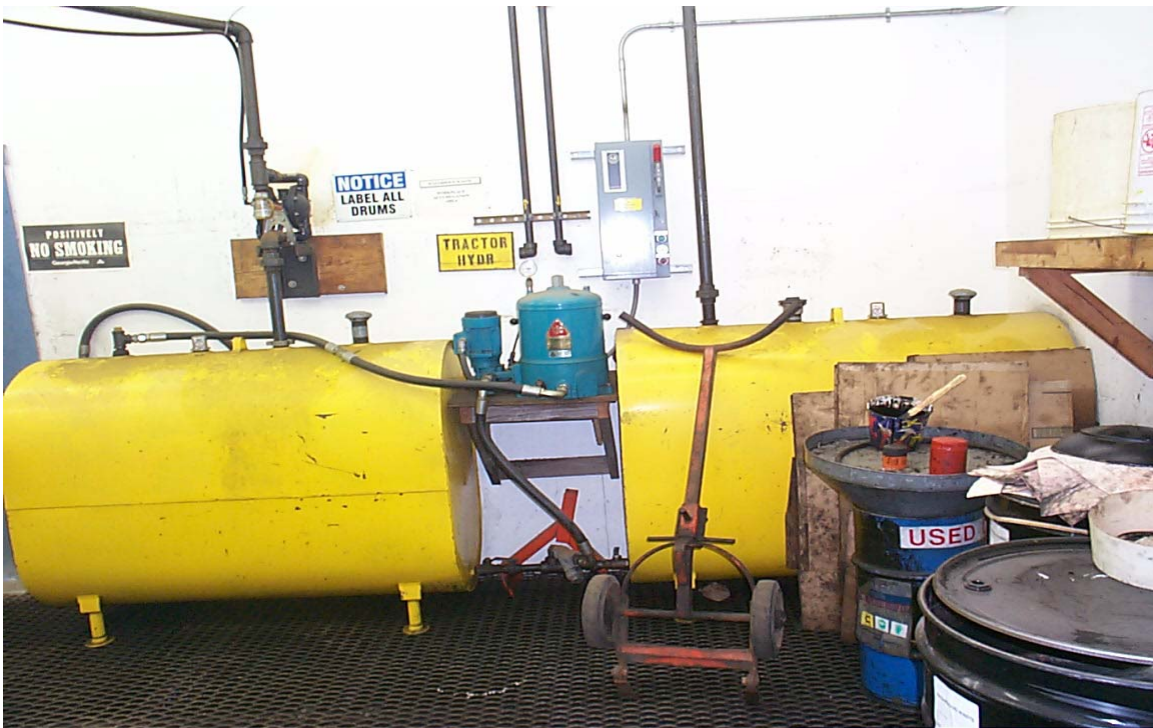
Photo 12. West Shed – Mobile Equipment Shop.

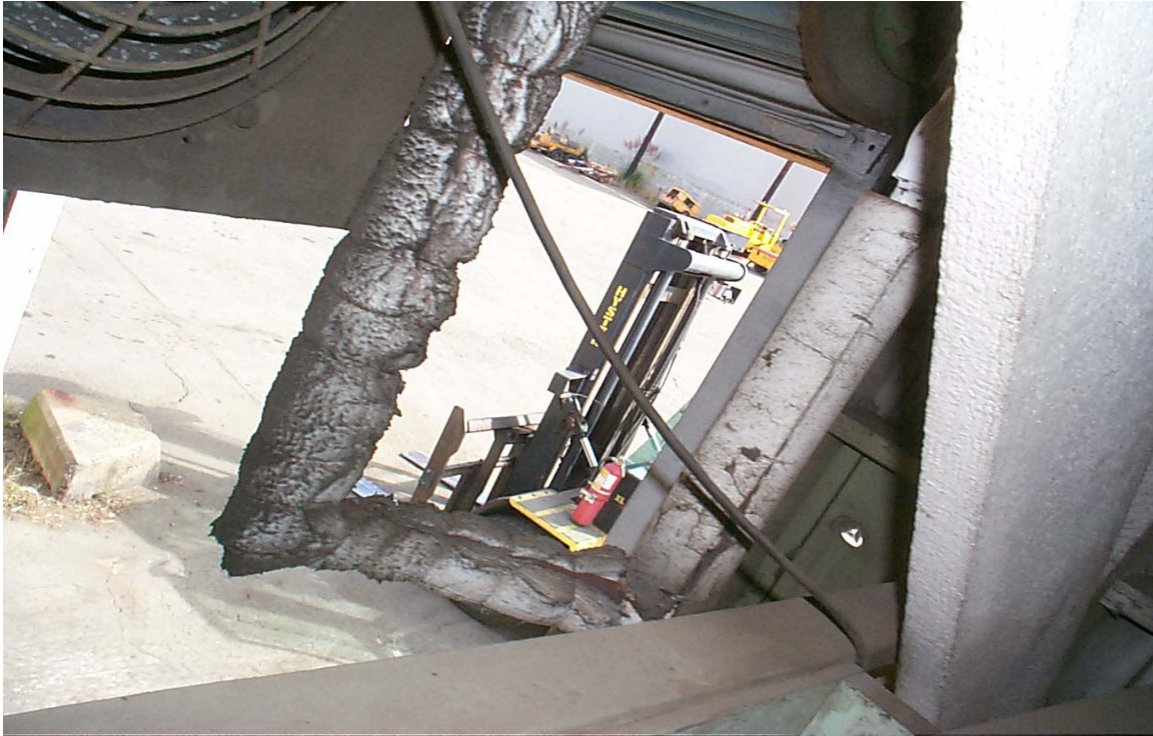
Photo 13. Steam Pipe insulation.

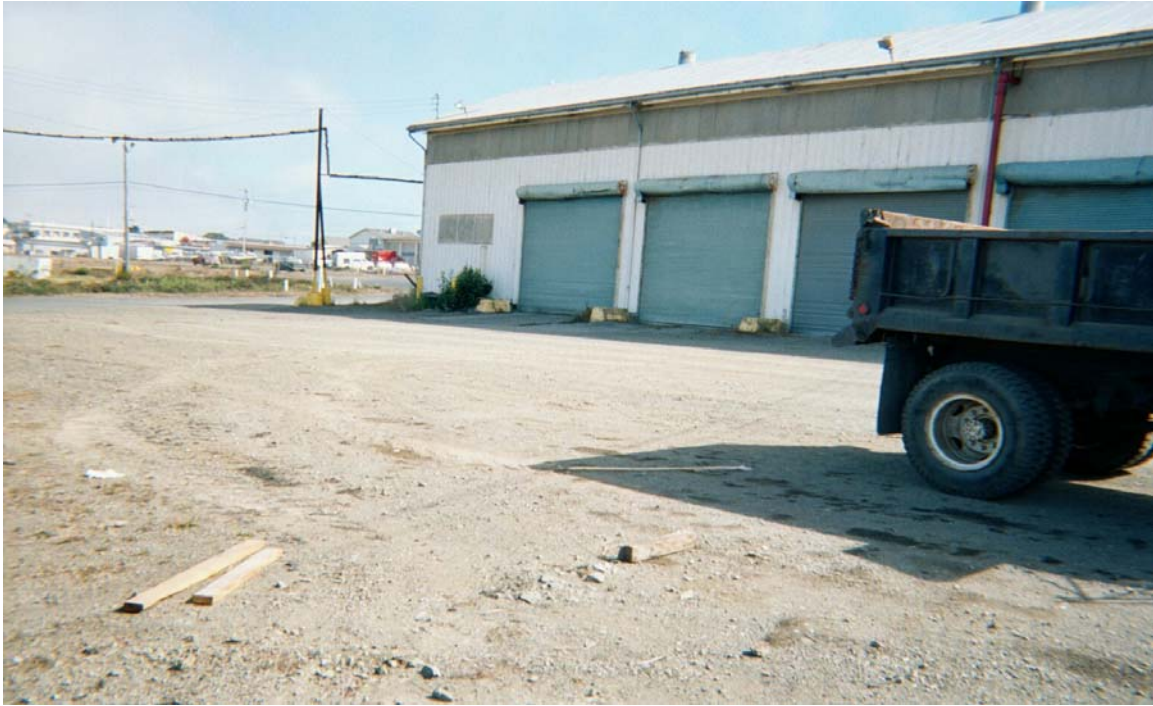
Photo 15. Western Side of Mobile Equipment Shop.

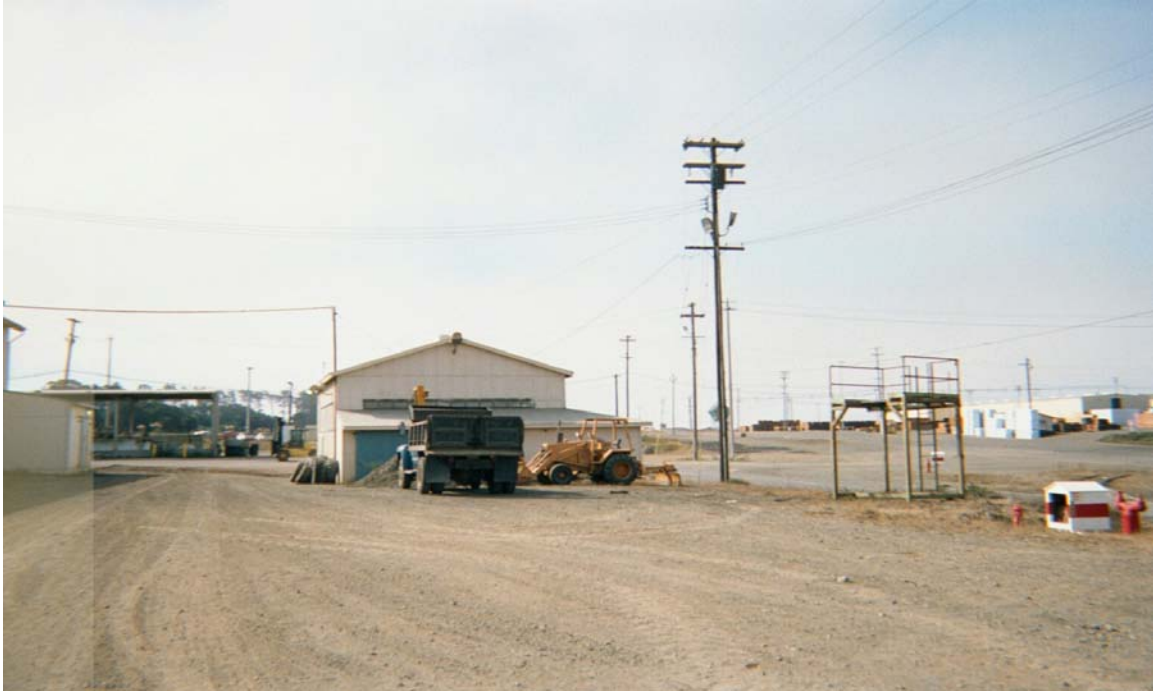
Photo 17. Tire Shop Building.

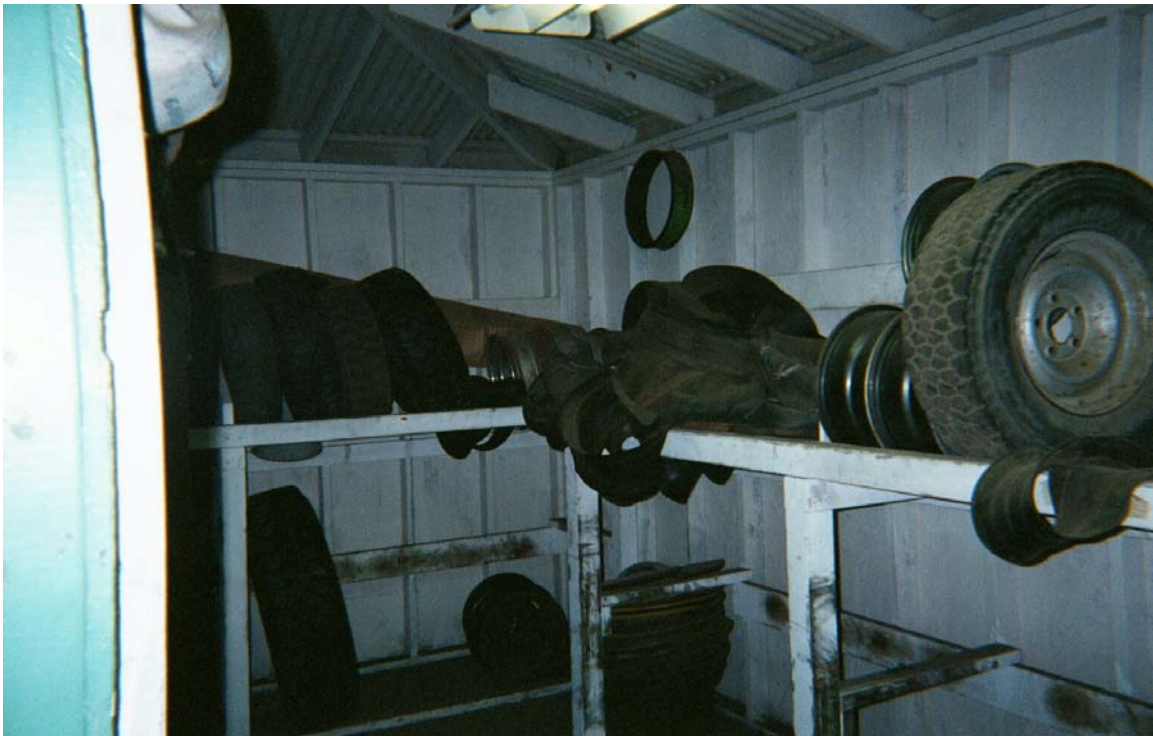
Photo 18. Inside Tire Shop Building

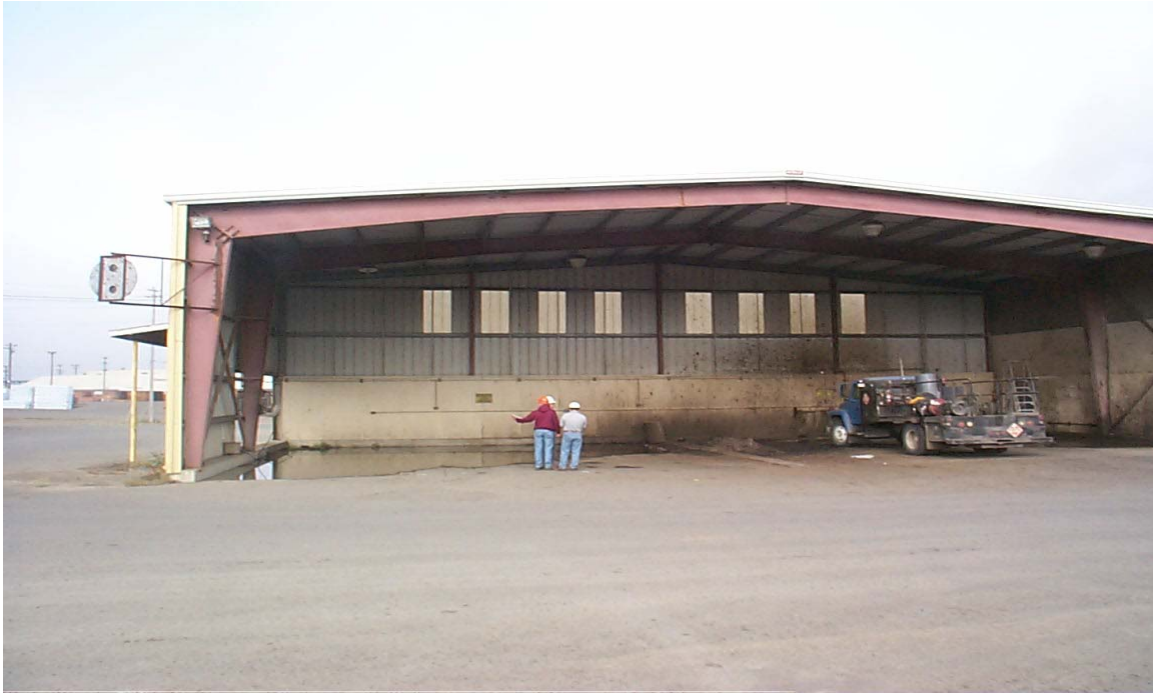
Photo 19. Washdown and Repair Building.

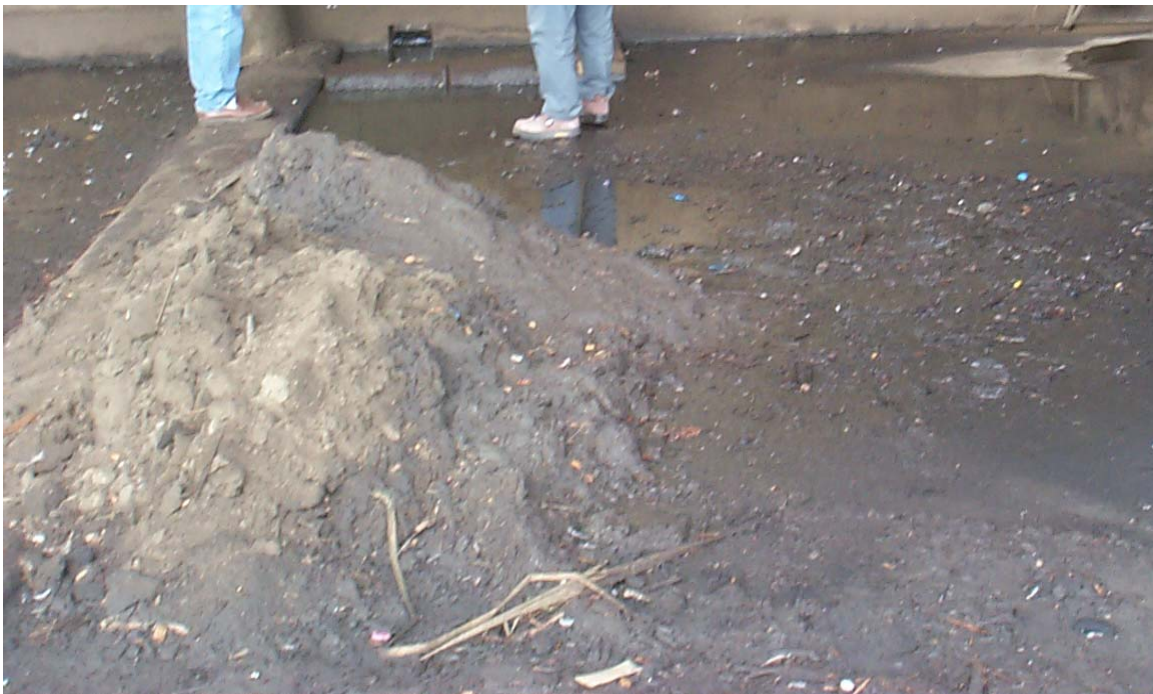
Photo 20. Washdown and Repair Building – Soil Stockpile. Soil Stockpile has been removed.

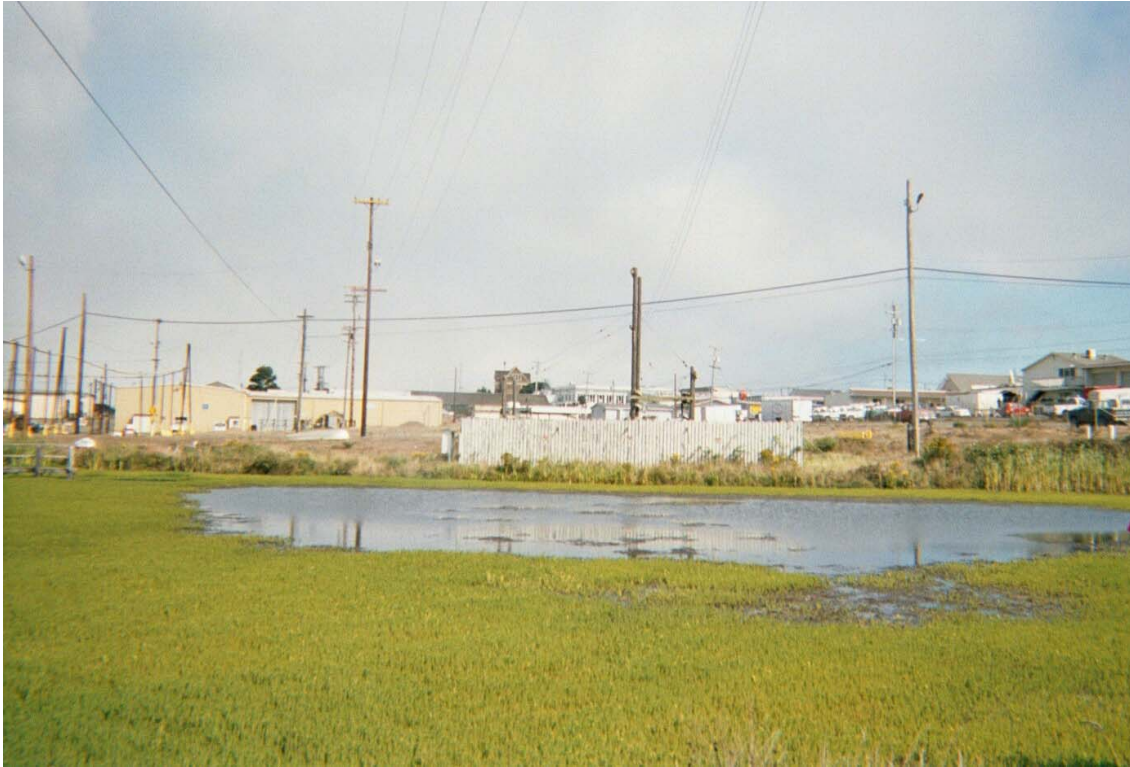
Photo 21. Transformer Pad located near small pond.

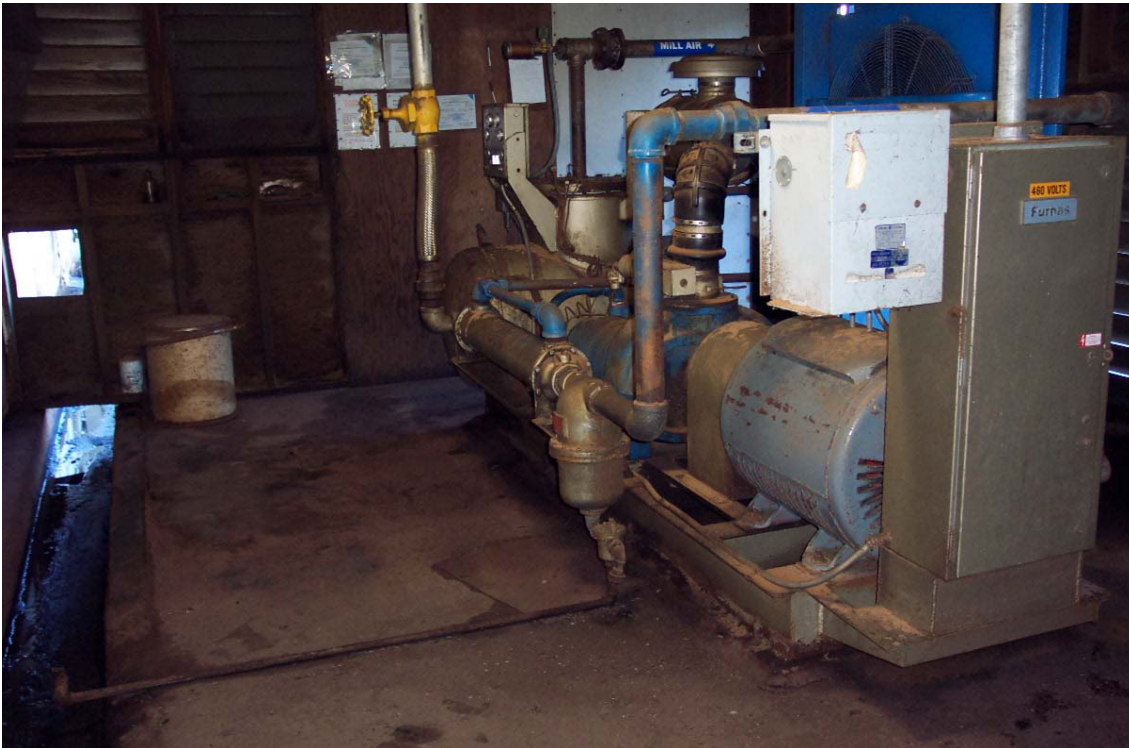
Photo 2. Air compressor located in the central area of Planer Mill No. 2.

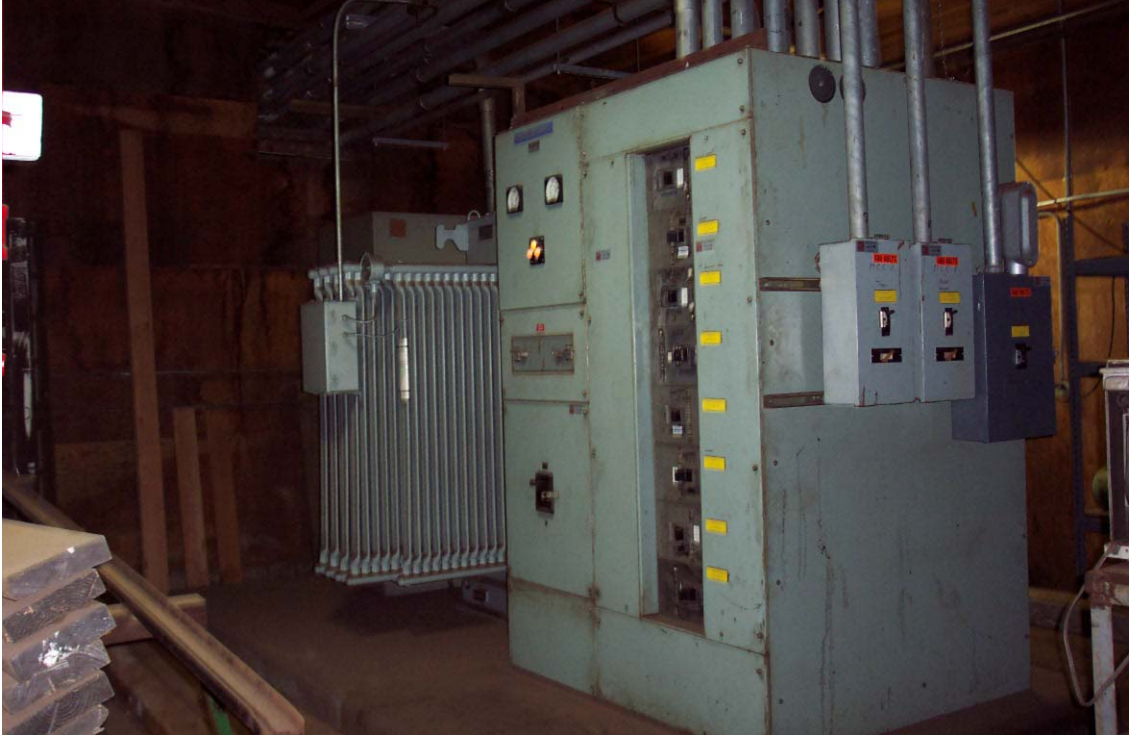
Photo 3. Transformer located in the central area of Planer Mill No. 2.
